ZULFAQAR Journal of Defense Science, Engineering & Technology

STRUCTURAL ANALYSIS OF BULKHEAD PATCH REPAIR DUE TO HEAT DAMAGE

The integrity of the aircraft structure after a permanent repair requires thorough engineering analysis. In this study, the aircraft's defective Bulkhead was damaged due to heat exposure and repaired with a patching technique known as a bulkhead patch repair. The study aimed to analyse the repair carried out using numerical calculation and finite element analysis. The first result of the numerical calculation shows that the repair part (stainless steel) will restore the original part (AA7050) strength capability. The second result from the LS-Dyna analysis shows that heat damage had caused the material (AA7050) strength to deteriorate significantly. The final loads testing using LS-Dyna analysis on components shows the patch repair scheme conducted was capable of strengthening the damaged part by transferring the applied loads to repair part. The outcome of this study justified that for better maintenance action (structural integrity consideration), the damaged Y453 Bulkhead needed to be replaced instead of conducting permanent repair.

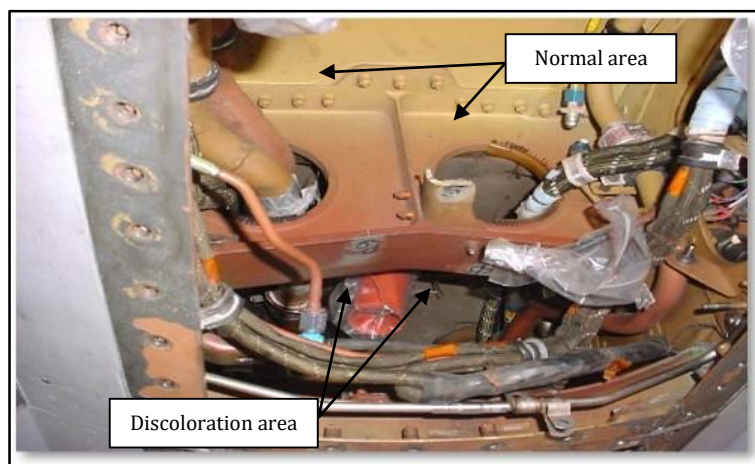
Fig. 2: Heat Damage on AA7075 Y453 Bulkhead

In a comparative study done on the variety of aluminium alloy material, there was a drop of 90% of the material's tensile strength when exposed to temperature elevated from room temperature till 370°C for 0.5-hour exposure[7]. This effect will reduce the operational capability of the component. Fig.2 shows the impact on heat damage based on discoloration. The effect of temperature on the aluminium structure will reduce the structure's operational capability by softening strain hardened and redistributing local stress in creep [8]. Creep is defined as a process of material deform permanently due to mechanical stress [9]. It occurs due to a high level of stress but still below the yield strength of the materials. For example, when subjected to heat for a long period, creep always increase with temperature increases. Stages of creep can be divided into three developments [10-11]; primary creep, which happens at a fast rate, secondary creep, which occurs at a steady pace and tertiary creep happens rapidly and rupture to failure. The author also mentioned that the creep generally happened at 30% to 40% of the materials melting temperature. For records, the melting temperature of aluminium alloy is in the range of 475 °C to 675 °C.

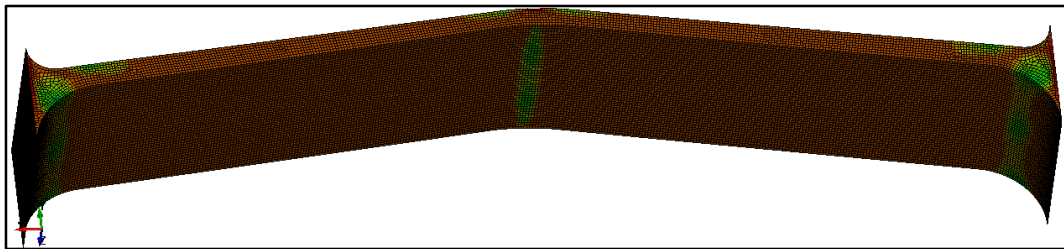
Fig. 8: Heat Damage Simulation Result

The effects of the elevated temperature on the original structure of AA7050 using the simulation are shown in Fig. 8. This condition can be compared with the actual condition in Fig. 9. The obvious effect was that the real structure was having discolouration and so as the simulation result. This can be defined as the depletion of strength due to elevated temperature.

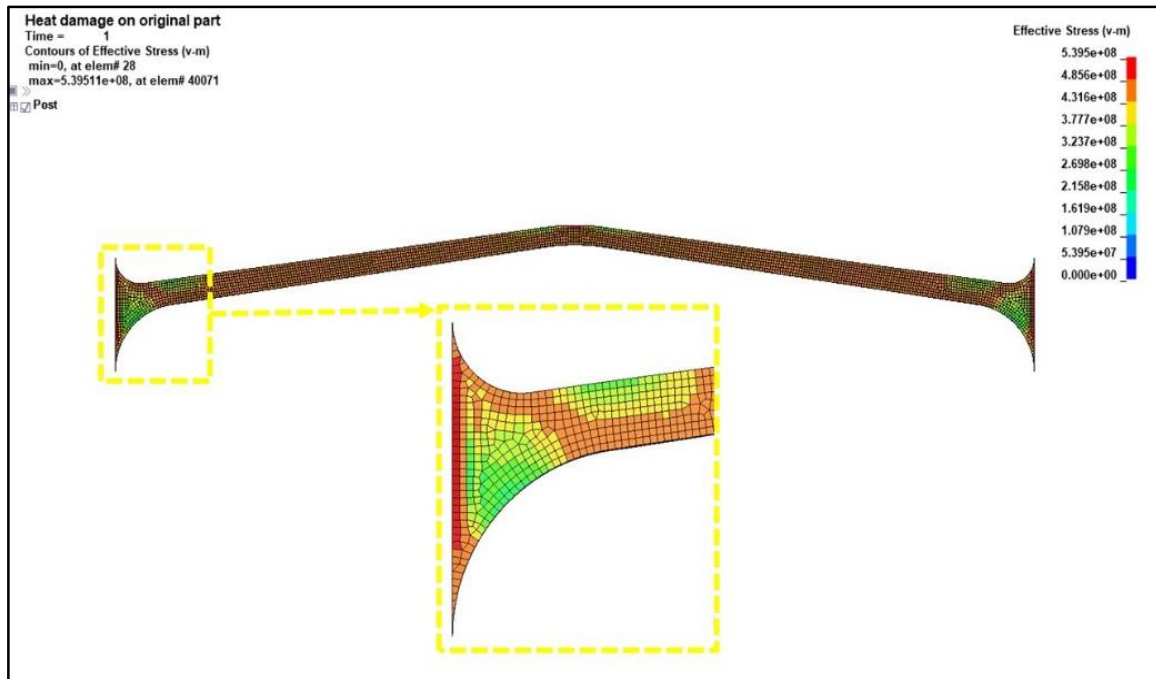
Fig. 10: Heat effects on effective stress

The highest stress was recorded on the areas of fix joints, whereas, the heat effect had caused repel force due to fix conditions. The highest effective stress (Von-Mises Stress) recorded as shown in Fig. 10 is $\sigma_{vm} = 539.5 \text{ MPa}$, while the yield strength of the material was only $\sigma_y = 441.3 \text{ MPa}$. Thus, the material of

original structure (AA7050) had failed due to σ_{vm} higher than σ_y ($\sigma_{vm} > \sigma_y$). The expansion due to heat on original structure is about 0.38 mm in horizontal direction as shown in Fig. 11.

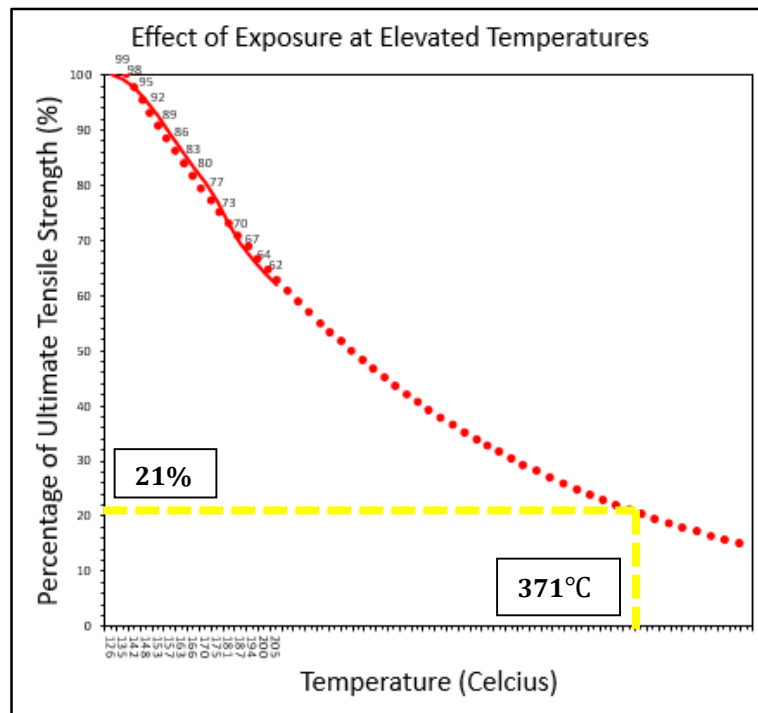
Fig. 12: Effect of Exposure on Elevated Temperature [11]

The outcome of the simulation does not directly show the strength of the affected structure. The resultant strength can be defined using an experiment by estimation from the graph of the effect of exposure at the elevated temperature [11]. The graph in Fig. 12 shows the estimate tensile strength left after the heat damage. Based on graph extrapolation of 371 C effects, the strength was just 21% of the actual tensile

strength. Thus, in this case the actual tensile strength was $\sigma_t = 510.2$ MPa, then if only 21% of the tensile strength left, the strength of the AA7050 after heat damage will be $\sigma_{t_new} = 102.04$ MPa.

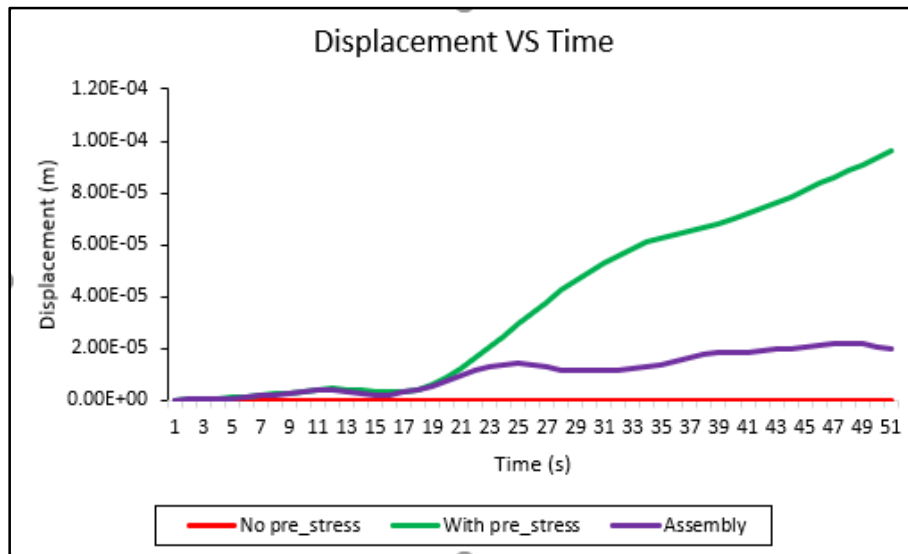
Fig. 16: Displacement vs time for the structure

As per Fig. 16, the red graph was steady with zero displacement, due to the load applied of 40kN could not cause any displacement to the original part. Then on the green graph, the displacement incremental was the highest when used with the same load, as the material's strength had been depleted to absorb the same load. And lastly, with an additional attachment of the repair part to the damaged part, on the purple graph, the displacement incremental was lower than the green graph but still showed deformation. This can be explained that, the damaged structure is transferring the load to the repair part, thus reducing the displacement effects.
