ZULFAQAR Journal of Defense Science, Engineering & Technology

STRUCTURAL ANALYSIS OF BULKHEAD PATCH REPAIR DUE TO HEAT DAMAGE

The integrity of the aircraft structure after a permanent repair requires thorough engineering analysis. In this study, the aircraft's defective Bulkhead was damaged due to heat exposure and repaired with a patching technique known as a bulkhead patch repair. The study aimed to analyse the repair carried out using numerical calculation and finite element analysis. The first result of the numerical calculation shows that the repair part (stainless steel) will restore the original part (AA7050) strength capability. The second result from the LS-Dyna analysis shows that heat damage had caused the material (AA7050) strength to deteriorate significantly. The final loads testing using LS-Dyna analysis on components shows the patch repair scheme conducted was capable of strengthening the damaged part by transferring the applied loads to repair part. The outcome of this study justified that for better maintenance action (structural integrity consideration), the damaged Y453 Bulkhead needed to be replaced instead of conducting permanent repair.

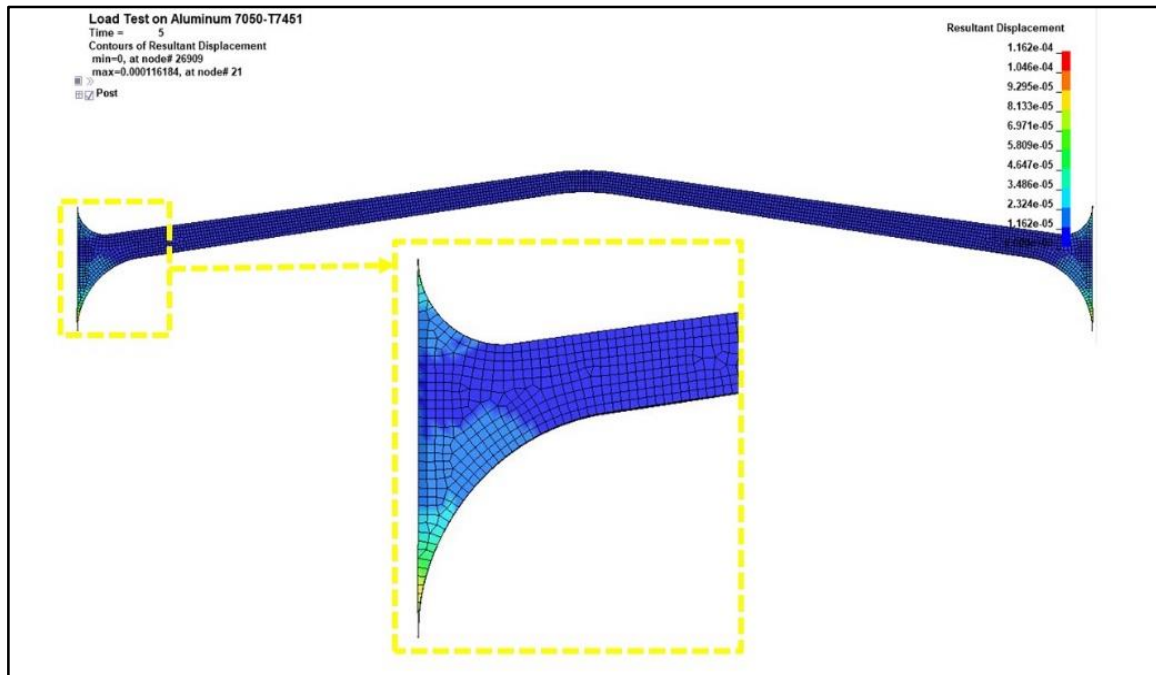
Fig. 13: Without Pre-Stress

Fig. 13 shows the displacement effect on the original structure without heat damage (no pre-stress). In comparison, Fig. 14 shows the displacement effect on the original structure after heat damage (with pre-stress). Fig. 15 shows the displacement of the damaged structure attached to the repair part (assembly part).
